**Saint Mary's**  
University

## **Monitoring Seasonal Changes in Surface Elevation of Intertidal Environments near the Windsor Causeway**

Dr. Danika van Proosdij  
Department of Geography

May 18, 2005

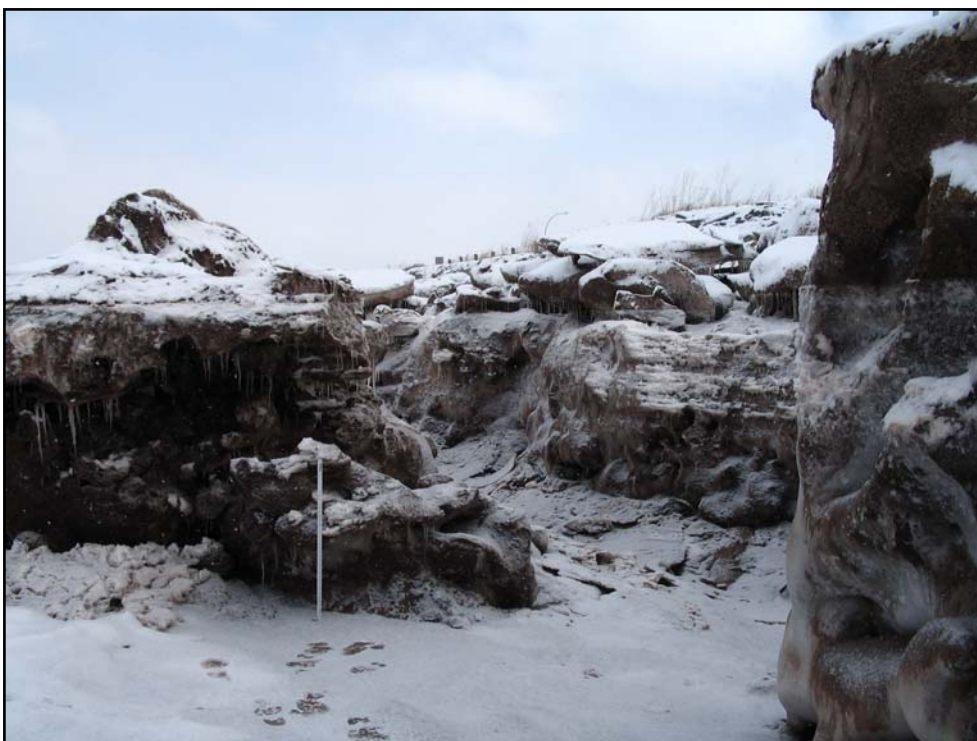
**Figure 16:** Approximately 2.5 m high by 4 m block of ice blocking creek channel. Meter stick for scale. Photo by D. van Proosdij on Feb. 25, 2005.

Sometime between February 11<sup>th</sup> and the 25<sup>th</sup>, a large ice block lodged itself within the large eastern creek channel (Figure 16). This effectively reduced the cross sectional area of the creek, likely increasing flow velocities within the remaining channel and eroding the outer creek bank. This process was observed visually on the rising spring tide later in the day on the 25<sup>th</sup>. Since tidal flow was blocked, sedimentation was observed on the downstream edge of the ice block. This channelization of flow has the potential to change the location of the creek thalweg. However, since topographic surveys were not conducted in May 2005, this could not be verified.

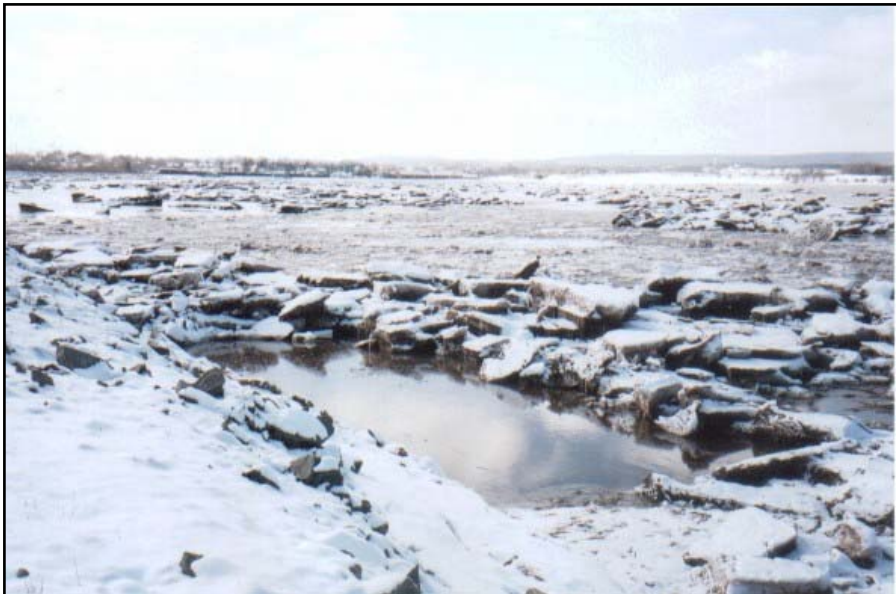
**Figure 17:** Temporary pool of tidal water formed along dyke near tourist bureau. Photo by D. van Proosdij, Feb. 25, 2005.

Ice blocks may also accumulate and form the banks of temporary pools on the marsh surface (Figure 17). These pools trap the highly turbid waters entering into the system (Figure 18), creating favorable conditions for particle settling.

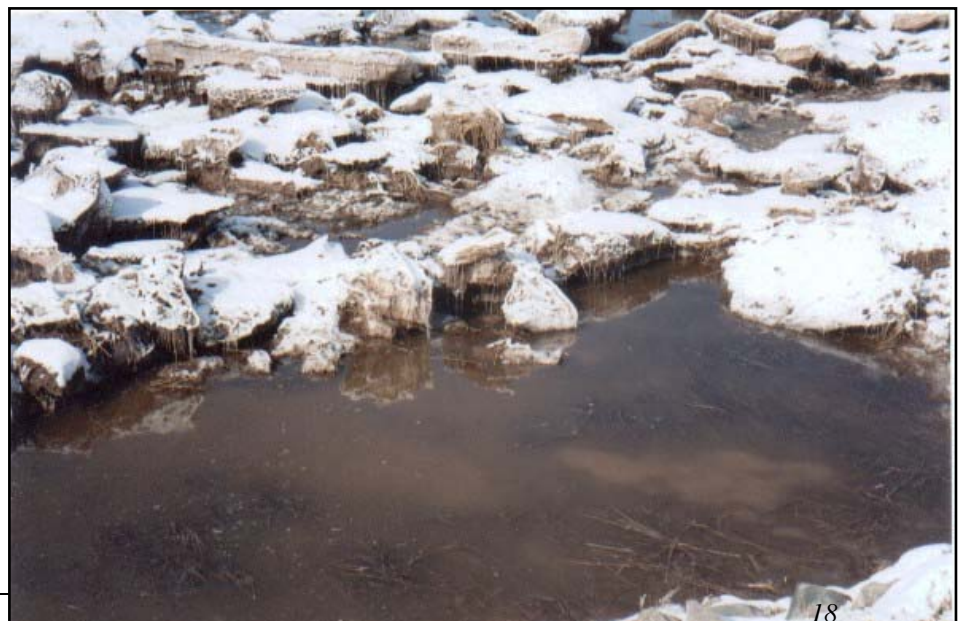
**Figure 18:** Plumes of sediment may be observed in suspension within these pools. In general, the suspended sediment concentrations are much higher during the winter months than during the summer. Photo by D. van Proosdij on Feb. 25, 2005.

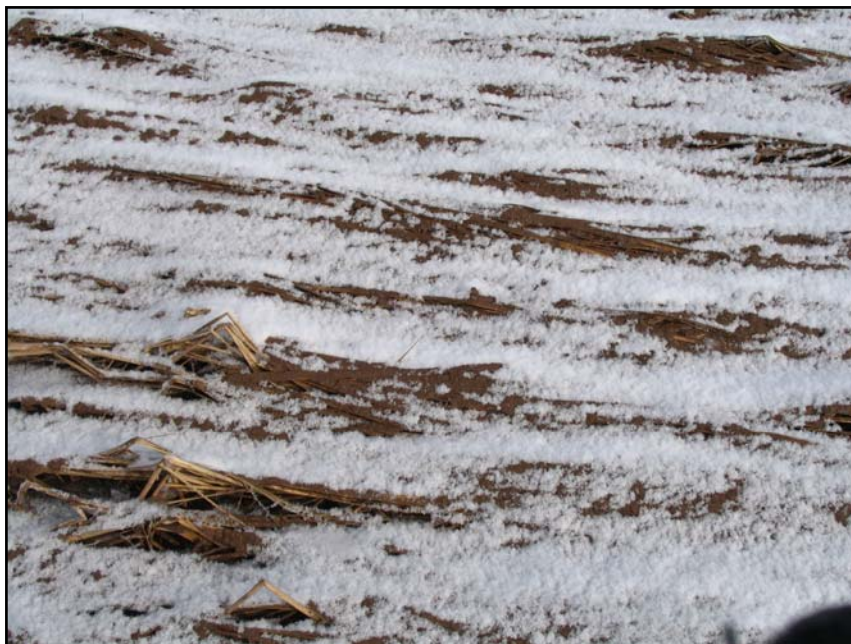
**Figure 19:** Sediment deposited over *Spartina alterniflora* along line 6. Overtime, the vegetation will decompose and be incorporated within the soil matrix. Photo by D. van Proosdij on Feb. 25, 2005.

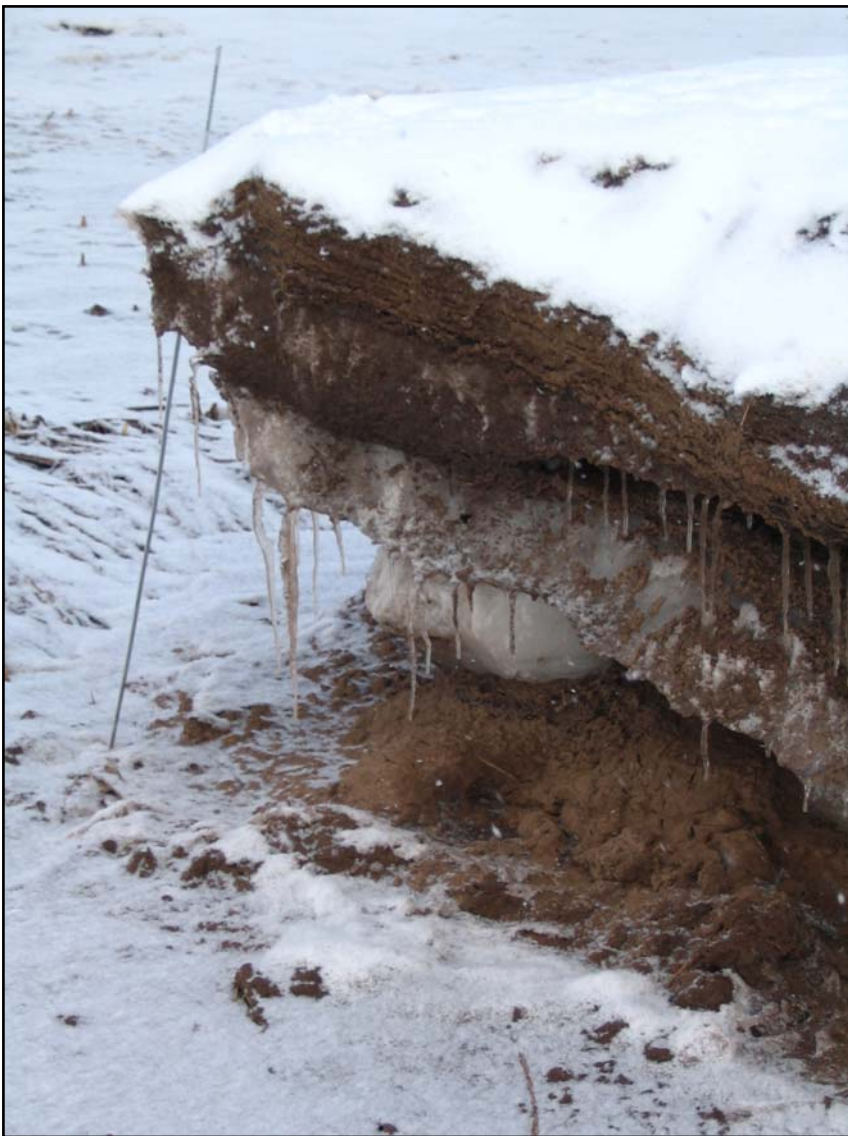
**Figure 20 (at right):** Sediment incorporated within matrix of ice block forming alternating layers of ice and sediment. Note sediment mound accumulating at base of the ice block. Meter stick for scale. Photo by D. van Proosdij on Feb. 25, 2005.

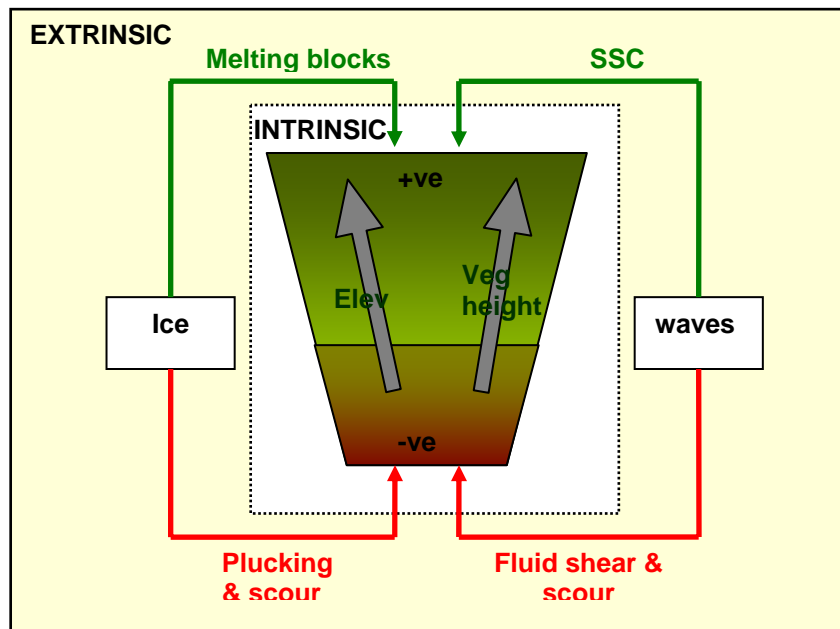
**Figure 20:** Preliminary conceptual model of factors controlling the change in surface elevation in the Windsor marsh / mudflat system. Ice and waves induce both positive and negative effects. Positive (+ve) effects result from melting ice blocks and high suspended sediment concentrations (SSC). Negative effects which will lower the surface include erosion from ice plucking and scour as well as direct surface shear from wave action. These external or extrinsic forces will be dampened (-ve) or enhanced (+ve) with increasing elevation within the tidal frame and vegetation height.

A preliminary conceptual model is presented in Figure 21 to summarize the main factors hypothesized to control the changes in surface elevation within this marsh /mudflat system. The model was developed based on data obtained from this study and ongoing studies within the upper Bay of Fundy (e.g. van Proosdij *et al.*, in press; van Proosdij *et al.*, 2004; Daborn *et al.*, 2003; Davidson-Arnott *et al.*, 2002; Ollerhead *et al.*, 1999). Dominant controls include those which are extrinsic to the marsh system (wave activity, ice, tidal range) and those which are intrinsic to the system (elevation within tidal frame and vegetation). These intrinsic variables will in turn influence how the marsh surface will respond to these external forces.
